Re: Dam Safety Inspection Report, Little Falls Dam, Field File No. 55.01

Underwater Inspection

**Little Falls Dam
Willow River State Park
St. Croix County, Wisconsin**

Tainter Gate Inspection

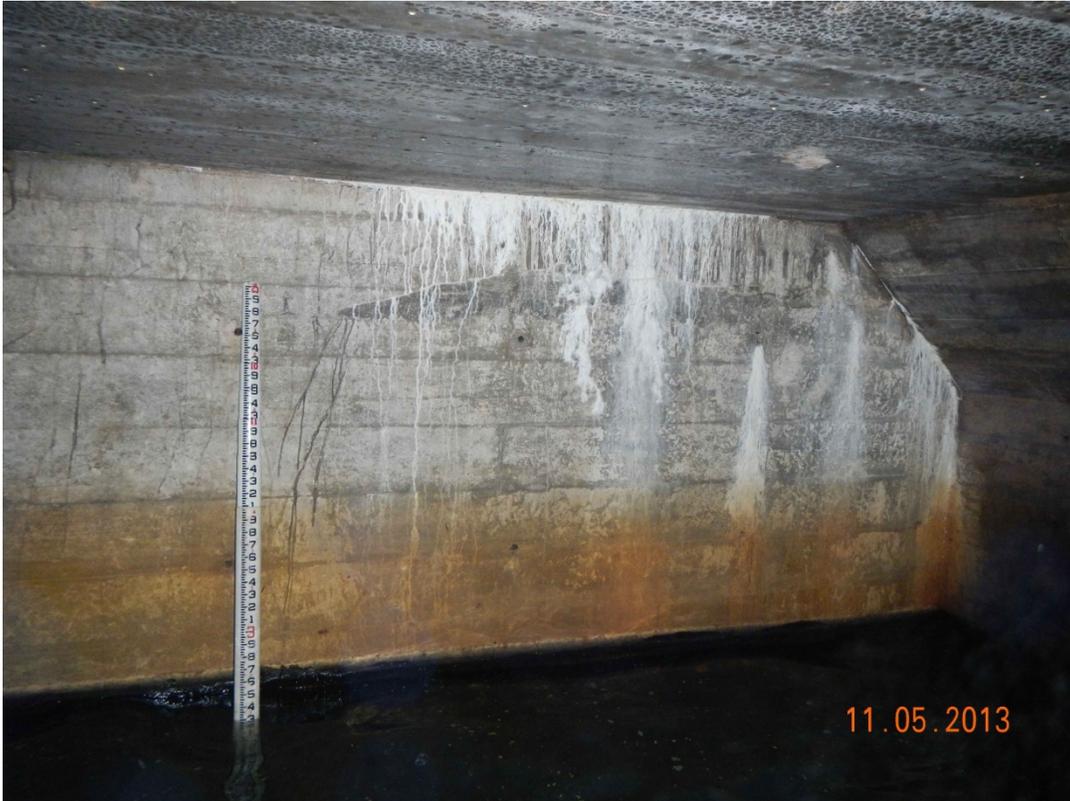
The concrete walls of the gallery are in good condition. The north wall of the north cell has a crack with efflorescence.

Photo 13: Bay 2 – north wall – crack with efflorescence

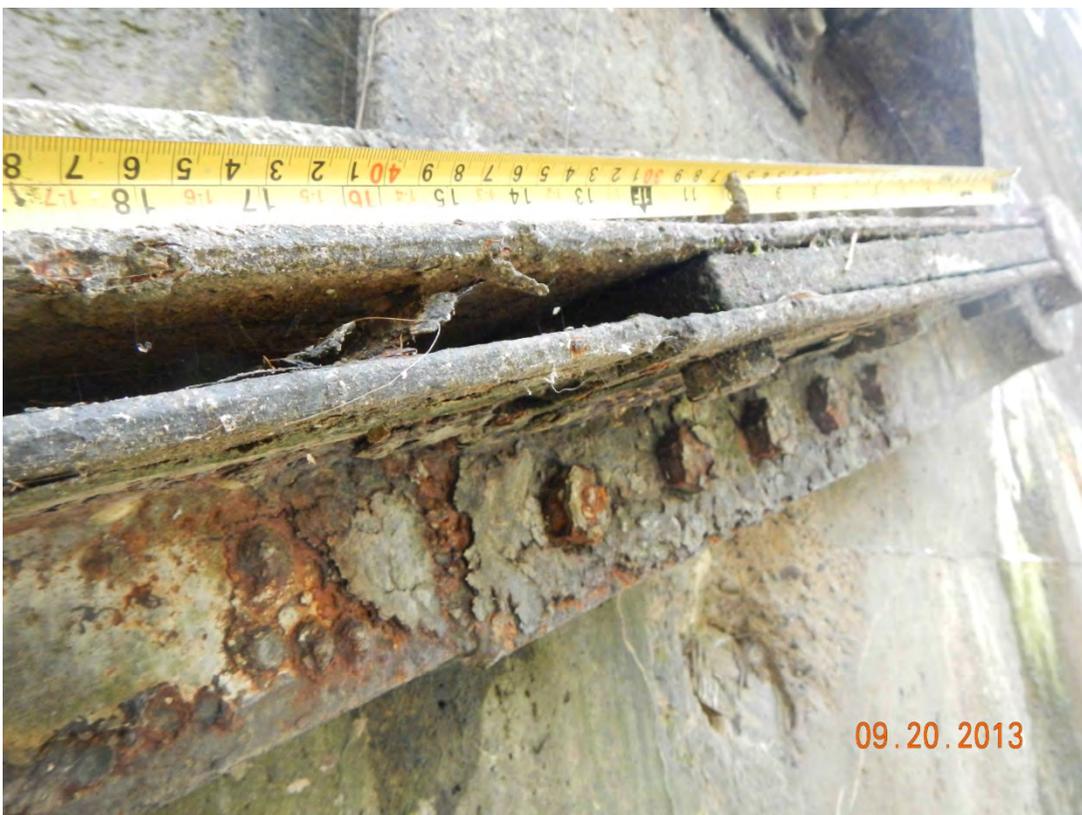
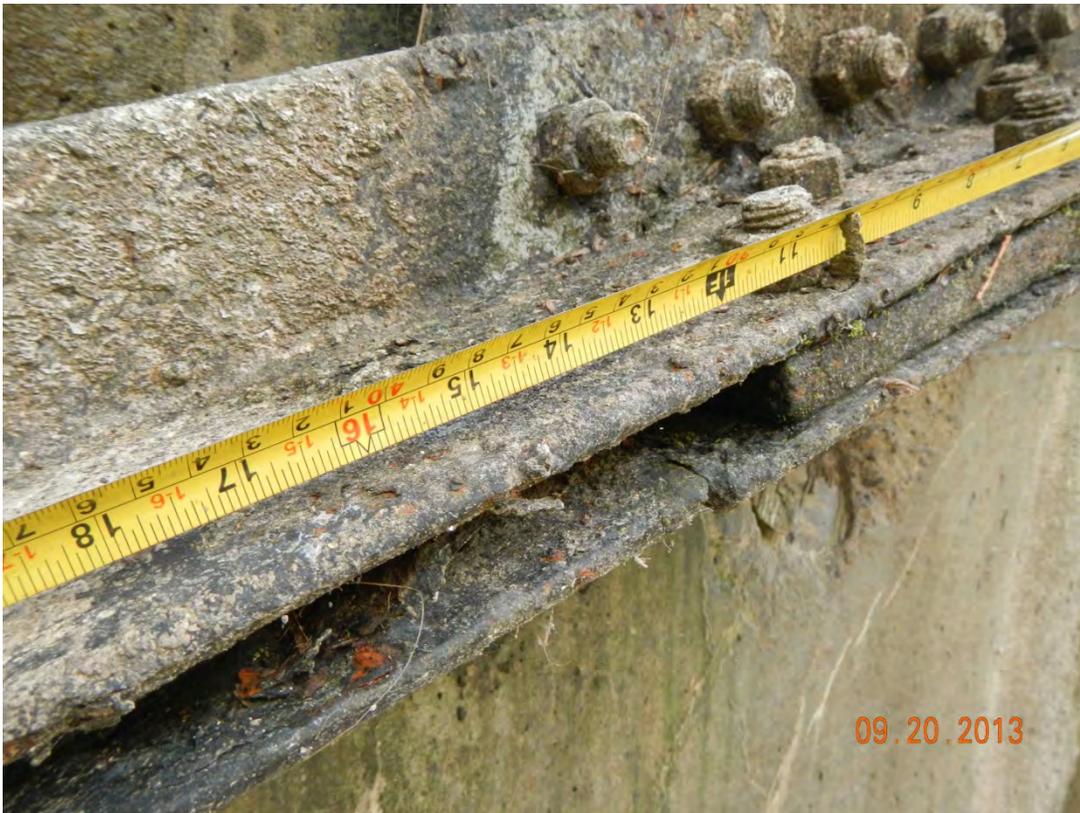
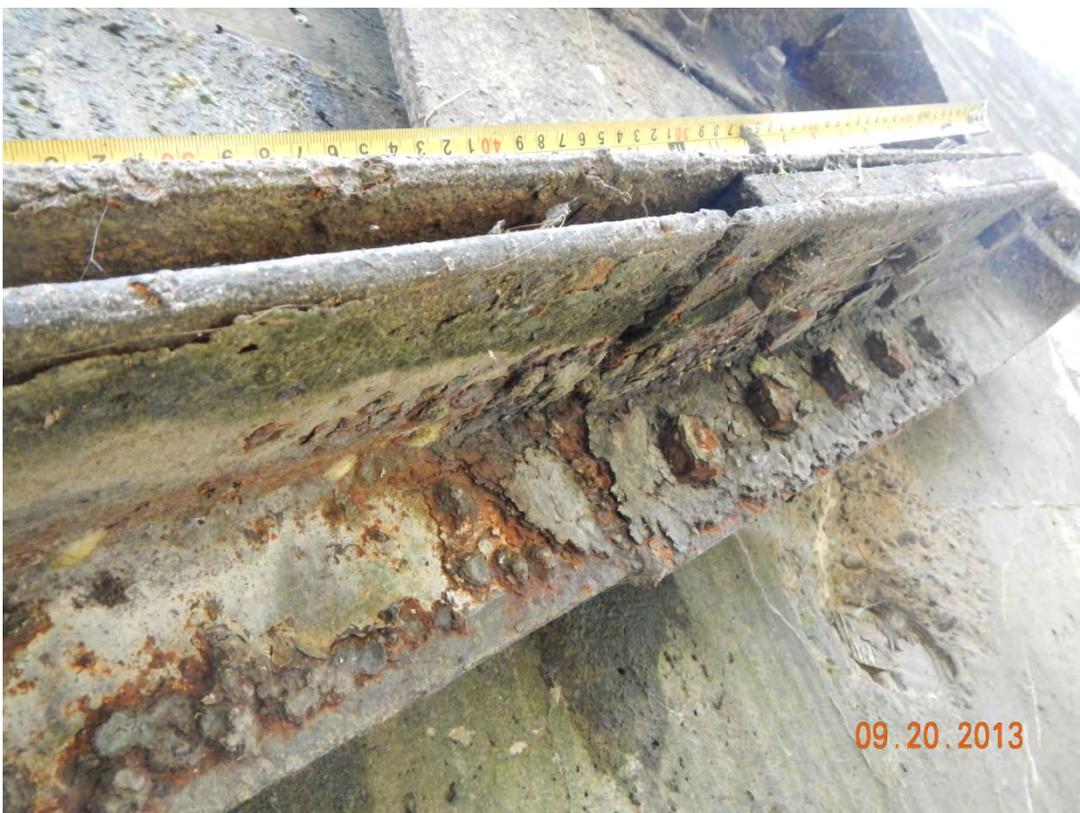
The bottom angle of the left arms lower double angle member is spliced with a full penetration weld. The weld is not as thick as the leg of the angle.

Photo 8: Gate 2 – bottom angle of left arm's lower double angle welded splice

Photo 9: Gate 2 – bottom angle of left arm's lower double angle welded splice

Photo 10: Gate 2 – bottom angle of left arm's lower double angle welded splice

At gate 2, the full penetration weld of the splice of the left arm's bottom angle of the lower double should be welded to full thickness of the leg of the angle.

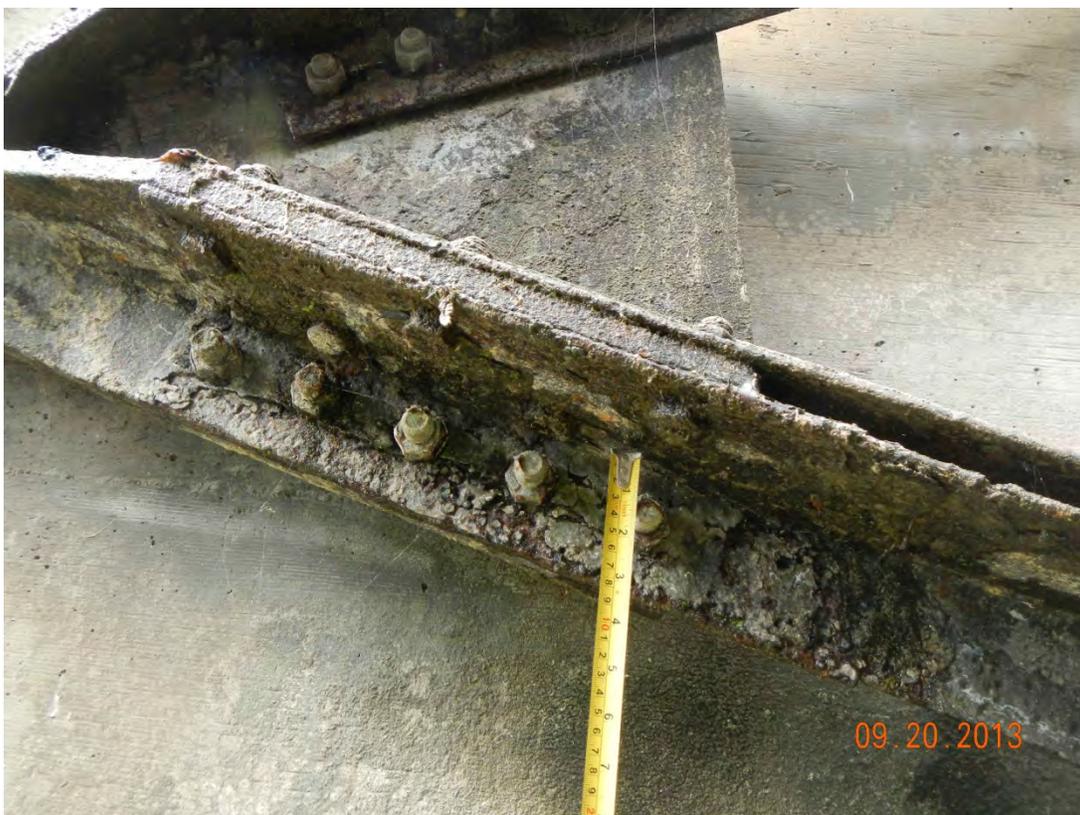
The bottom double angles of the right arm have corrosion with pitting.

Photo 12: Gate 2 – corrosion and pitting of lower double angles of right arm near trunnion

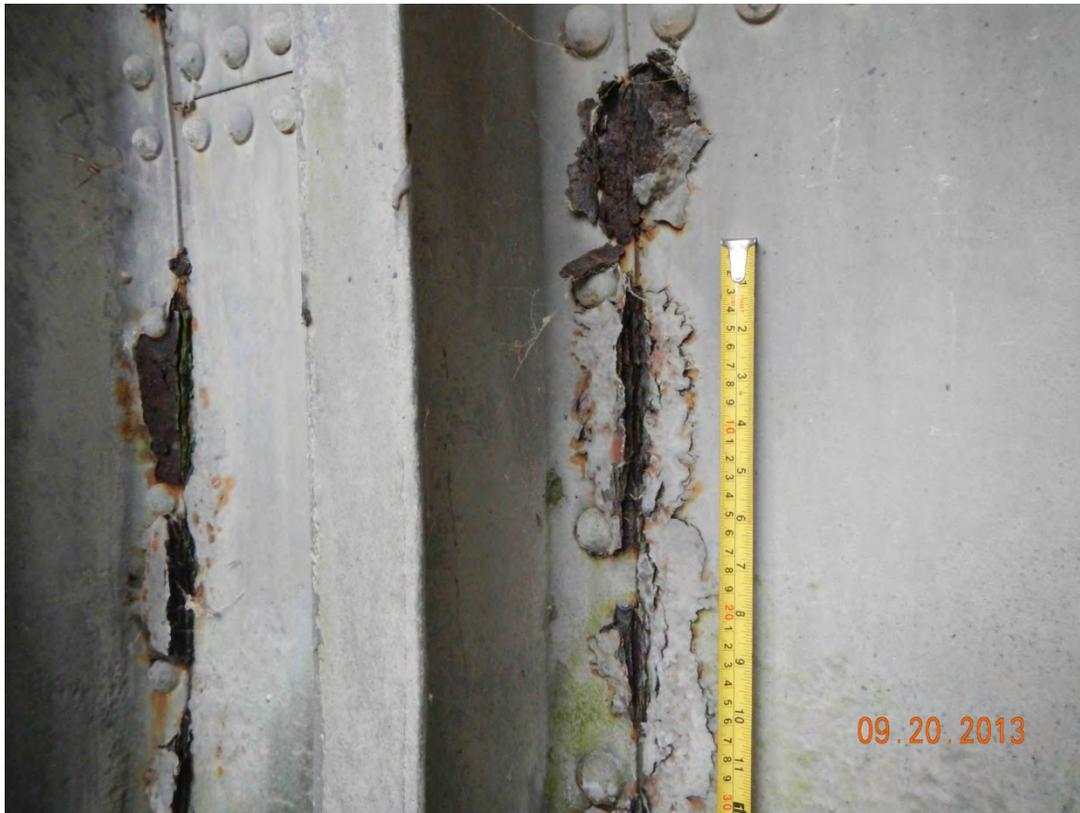
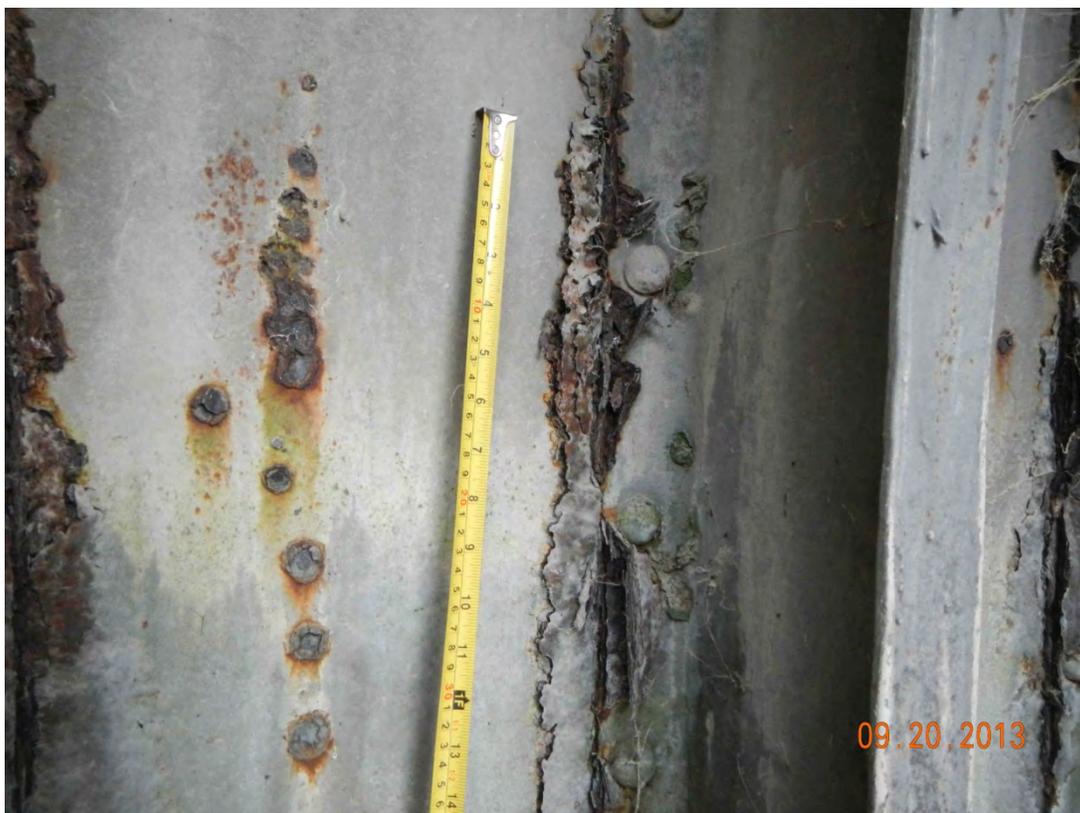
There is laminating corrosion at the skin plate and vertical beams. After removal of the laminations, it appears the thickness of the skin plate is reduced by 1/16 inch.

Photo 13: Gate 2 – laminating corrosion at skin plate and vertical beam

Photo 14: Gate 2 – laminating corrosion at skin plate and vertical beam

The gates should be cleaned, sand blasted and painted. Sand blasting may reveal additional section loss which should be analyzed.

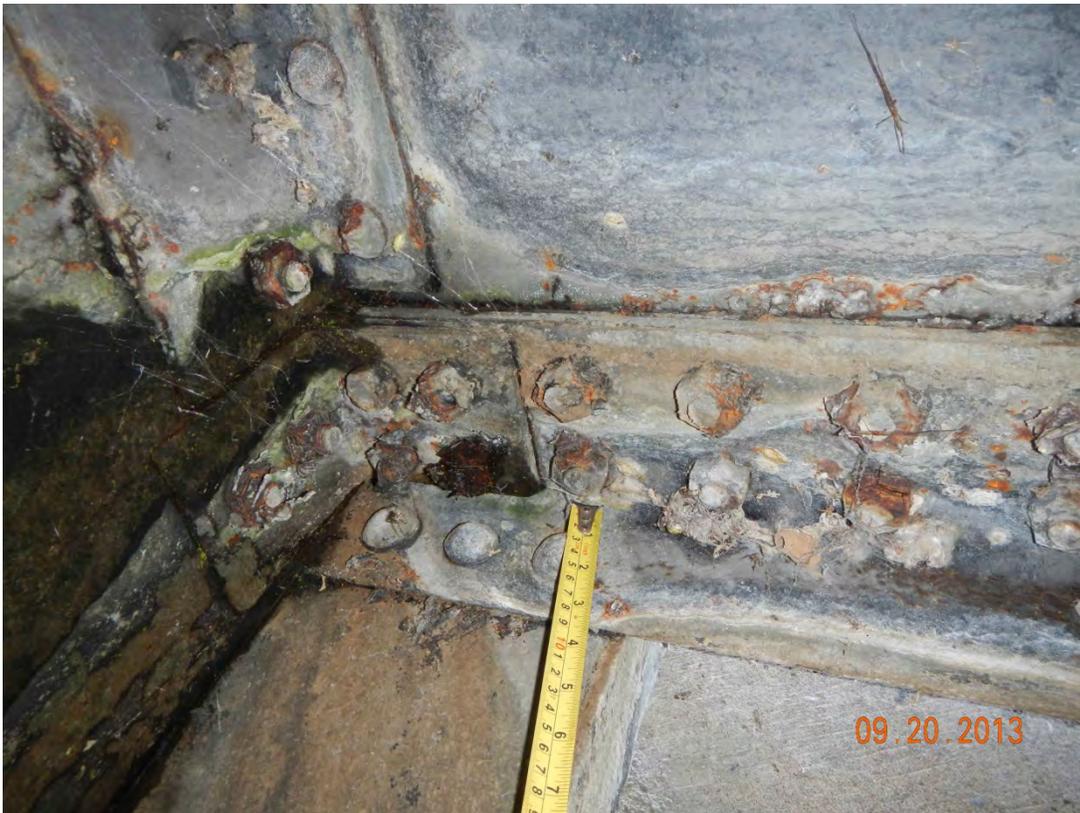
There is severe corrosion of the connection hardware causing section loss of the bolt heads and nuts.

Photo 15: Gate 2 – severe corrosion of nuts at top left arm near skin plate

Bolt heads and nuts with section loss should be replaced and any empty bolt holes should be filled. Any new hardware shall be high strength structural bolts and nuts of matching size.

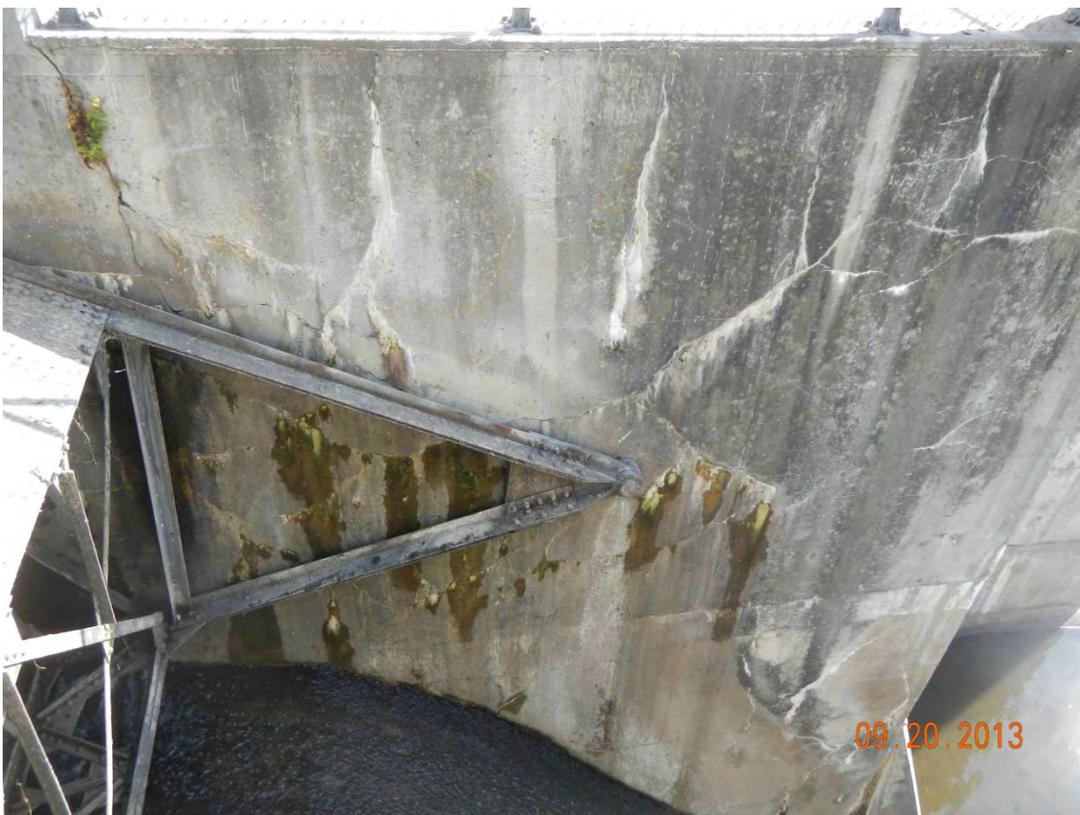
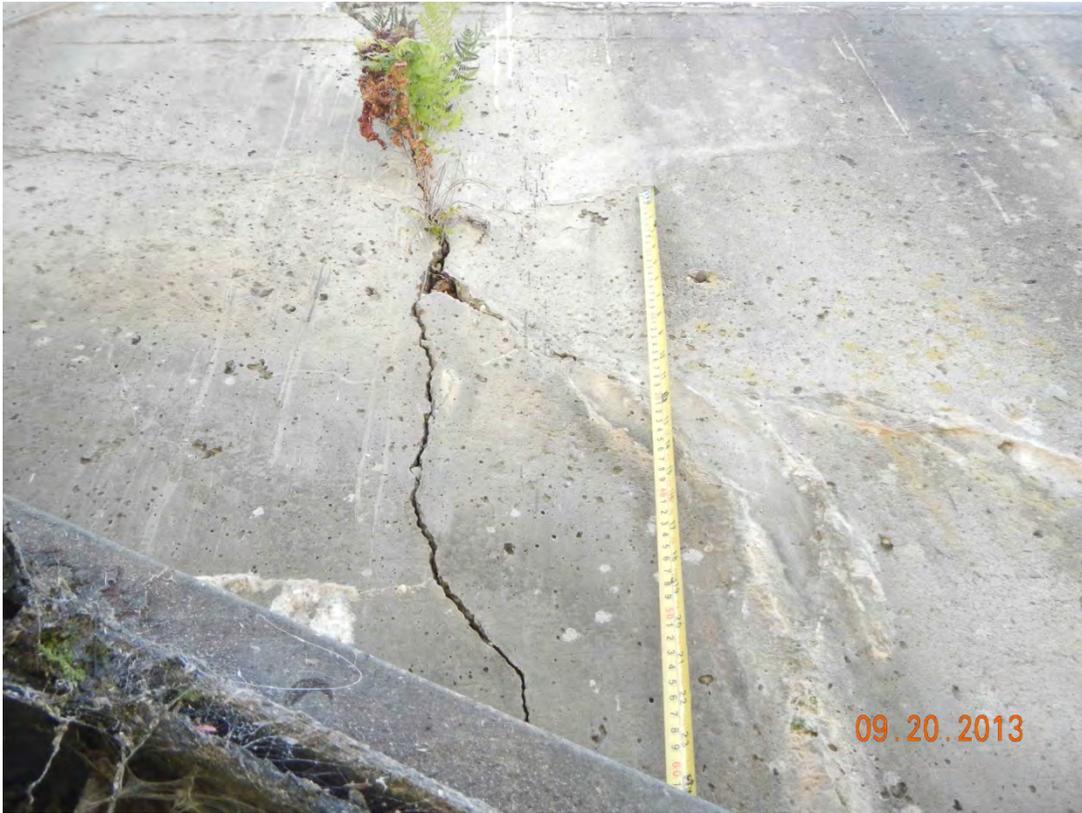
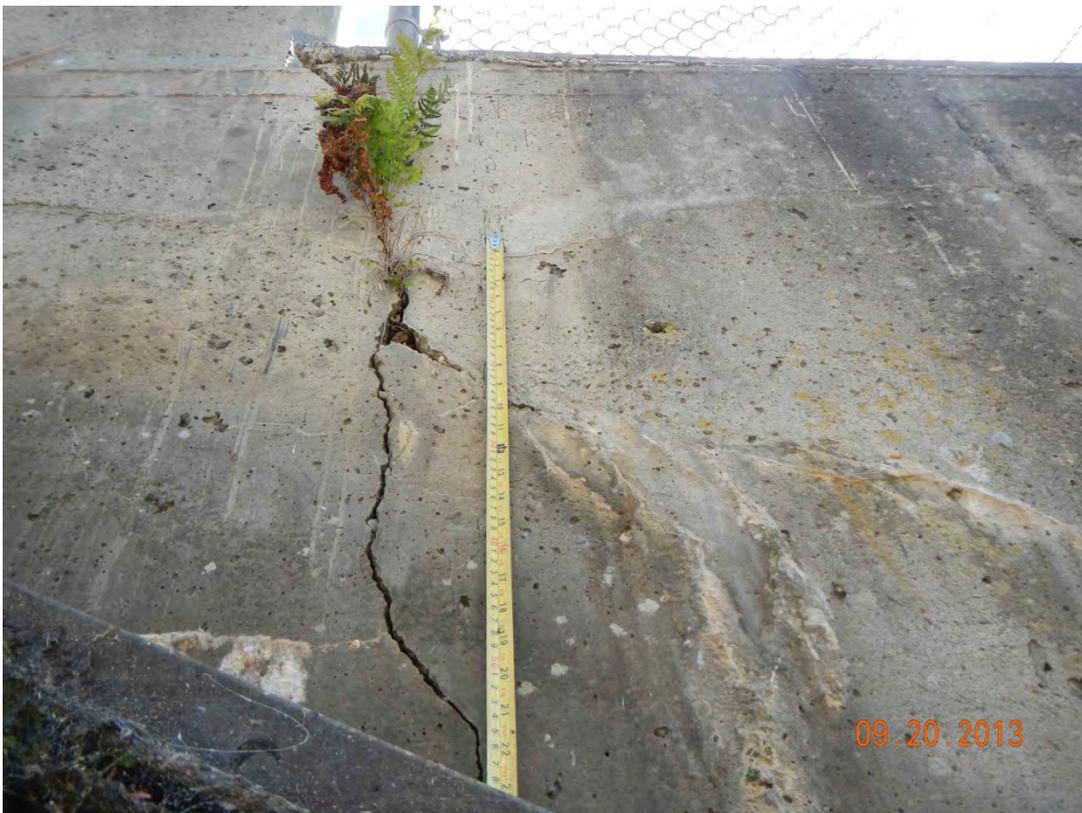
The left wall has several vertical and diagonal cracks.

Photo 16: Gate 2 – cracks in left wall

Photo 17: Gate 2 – vertical crack in left wall

Photo 18: Gate 2 – vertical crack in left wall

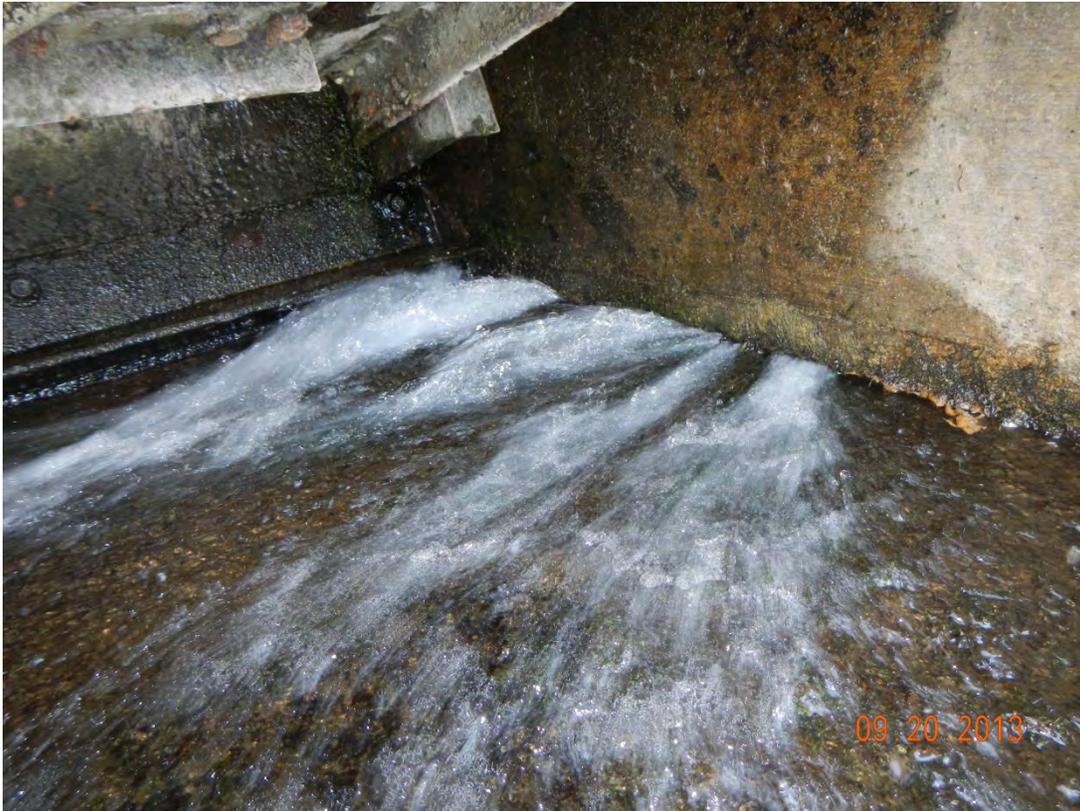
There is a leak at the bottom left corner that appears to be coming past the left wall.

Photo 19: Gate 2 – leak at bottom near left arm appears to be coming past left wall

At gate 2, the leak past the left wall should be stopped by filling the void with grout or other appropriate material.

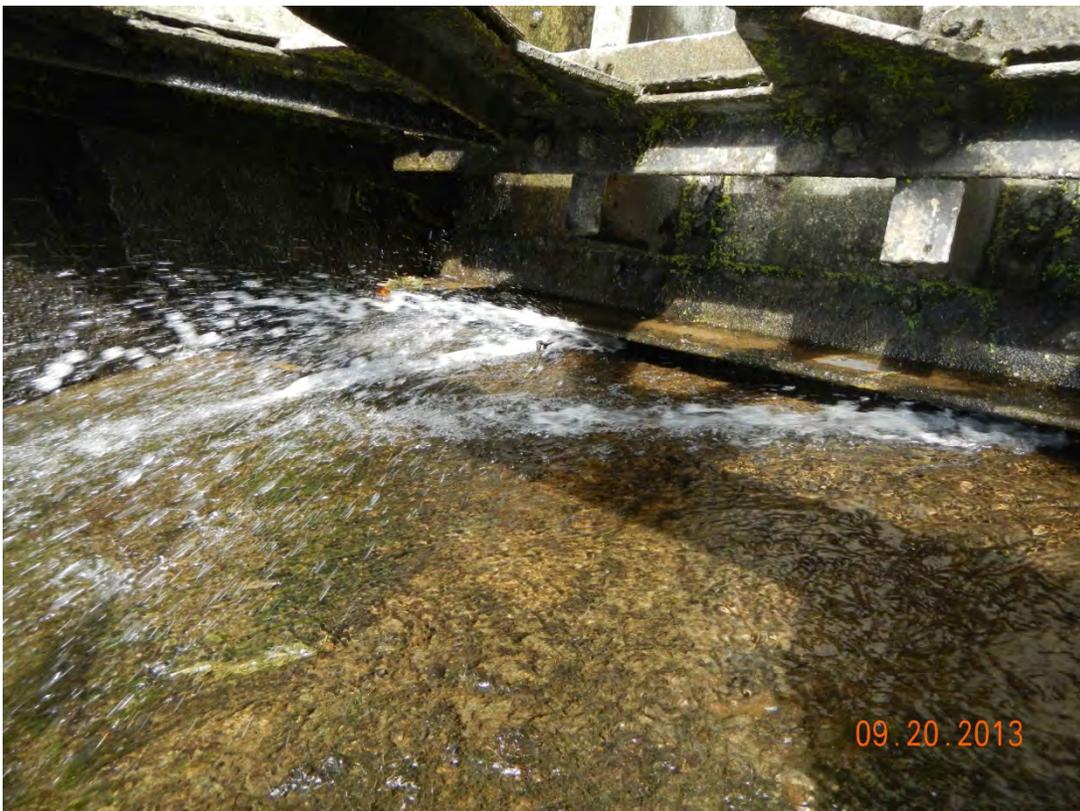
The bottom seals leak.

Photo 20: Gate 2 – leak at bottom seal near right arm

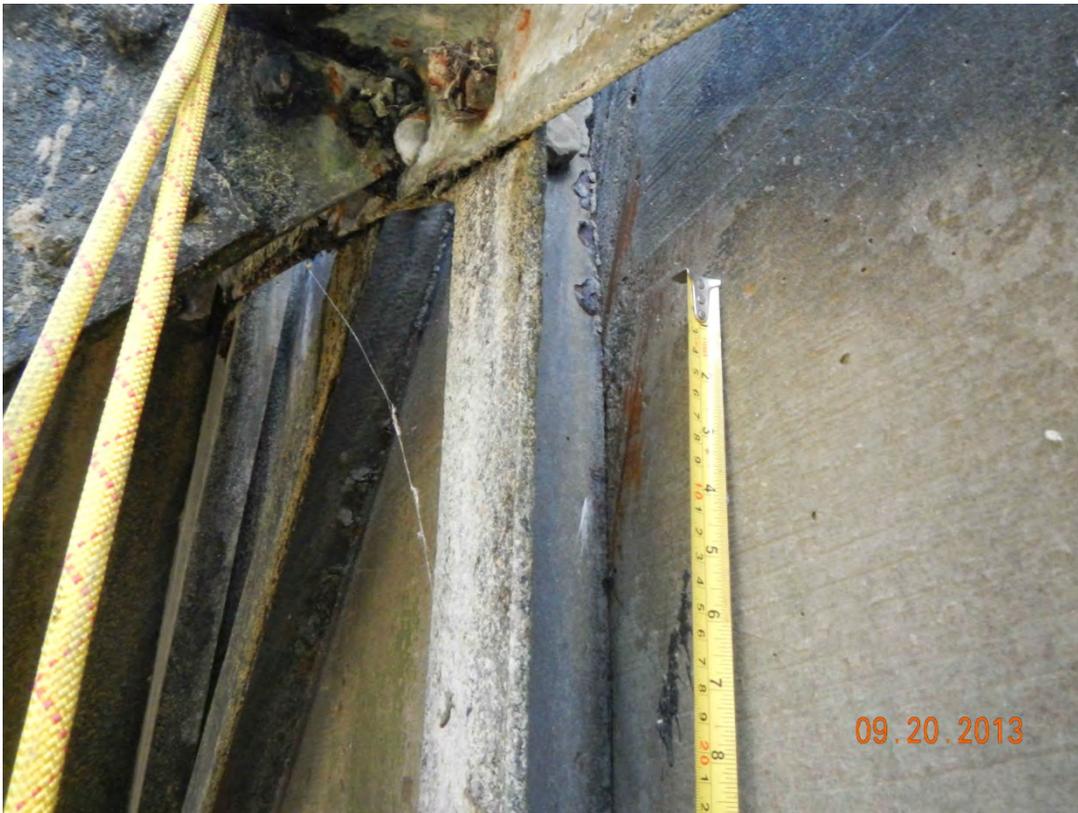
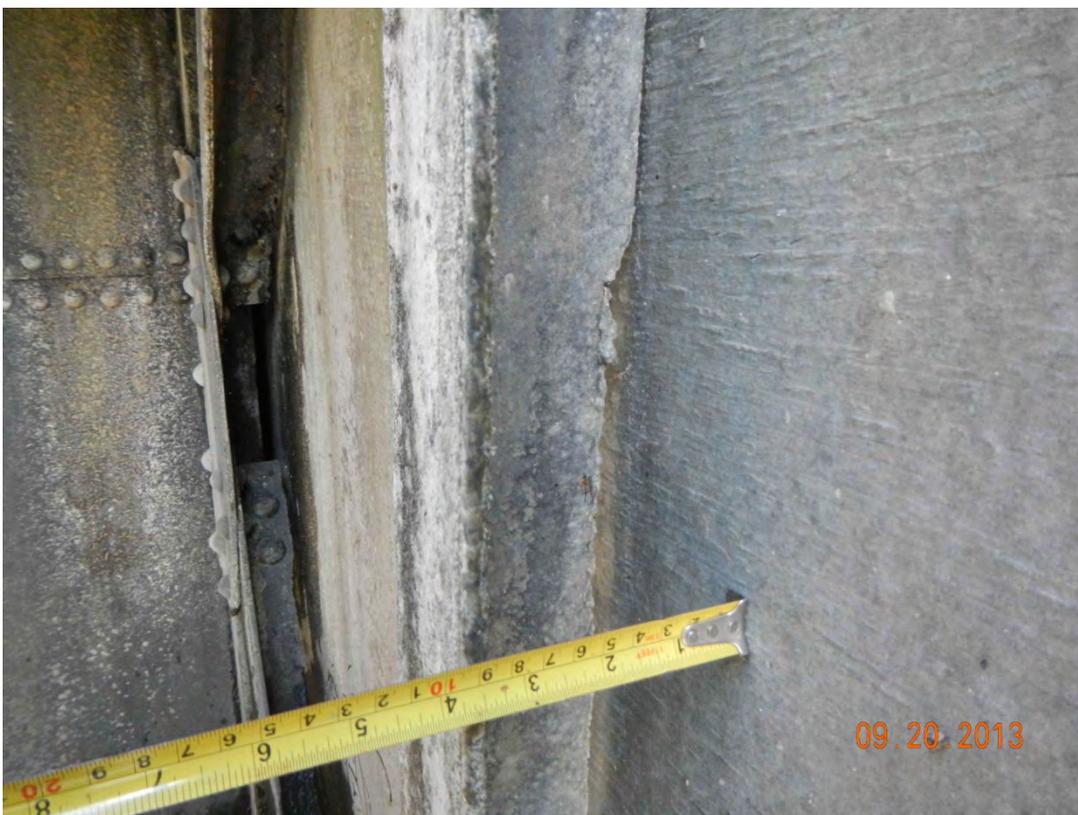
Some members of the arms have no clearance to the sidewalls. Other members have been cut to provide clearance. The remaining steel at the cuts has rough edges.

Photo 23: Gate 3 – vertical member at left arm with no clearance to wall

Photo 24: Gate 3 – vertical member at left arm cut for clearance to wall

The edges of all rough cuts should be ground smooth.

The arm members with no clearance to the side walls should be analyzed to determine how much section can be removed to provide clearance and if any replacement section is needed.

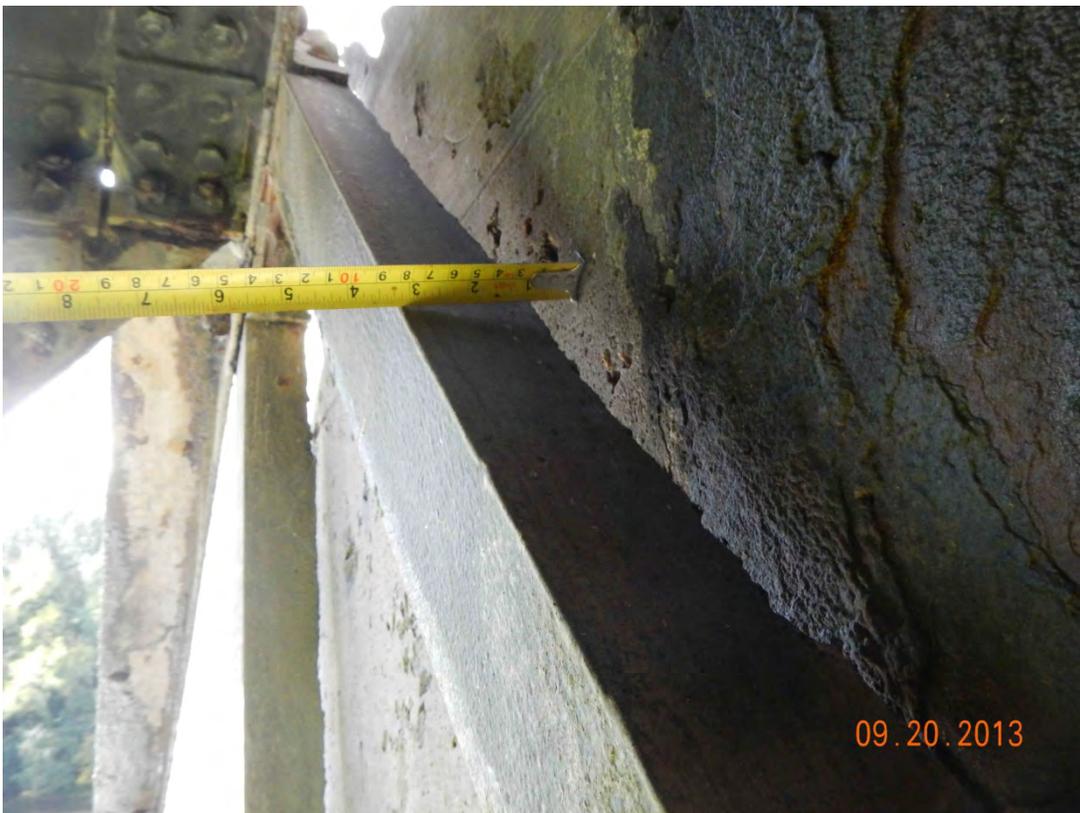
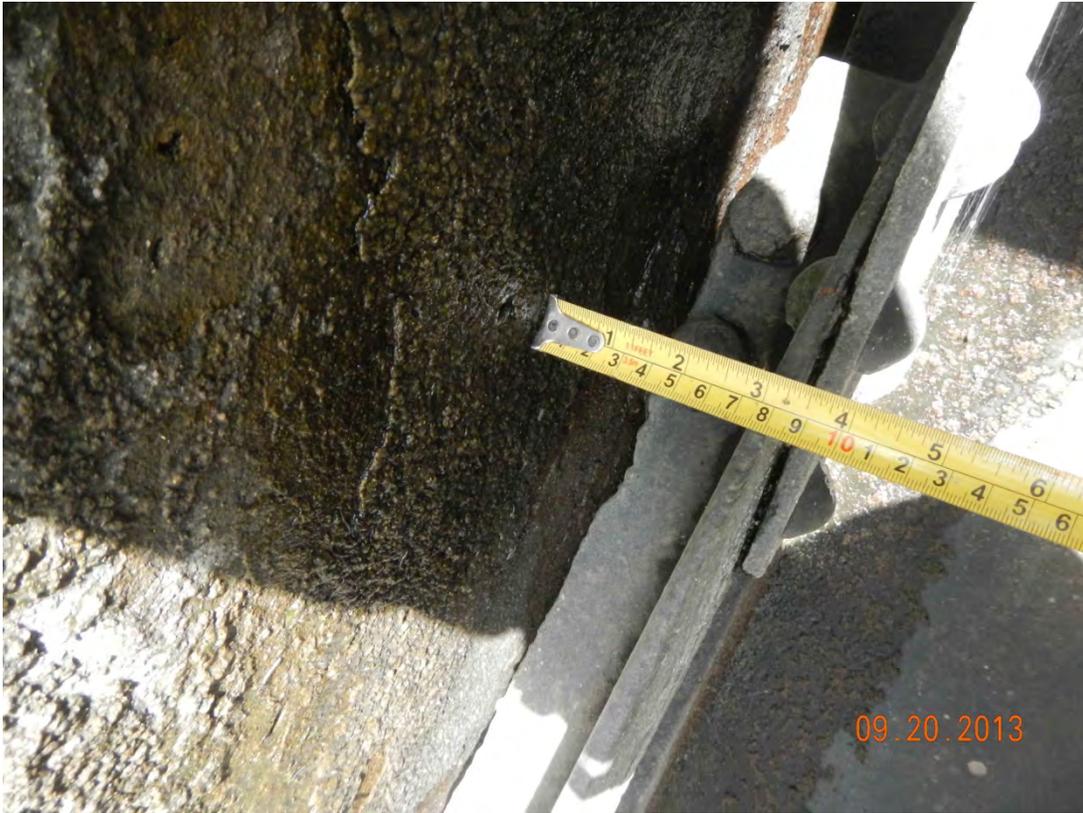
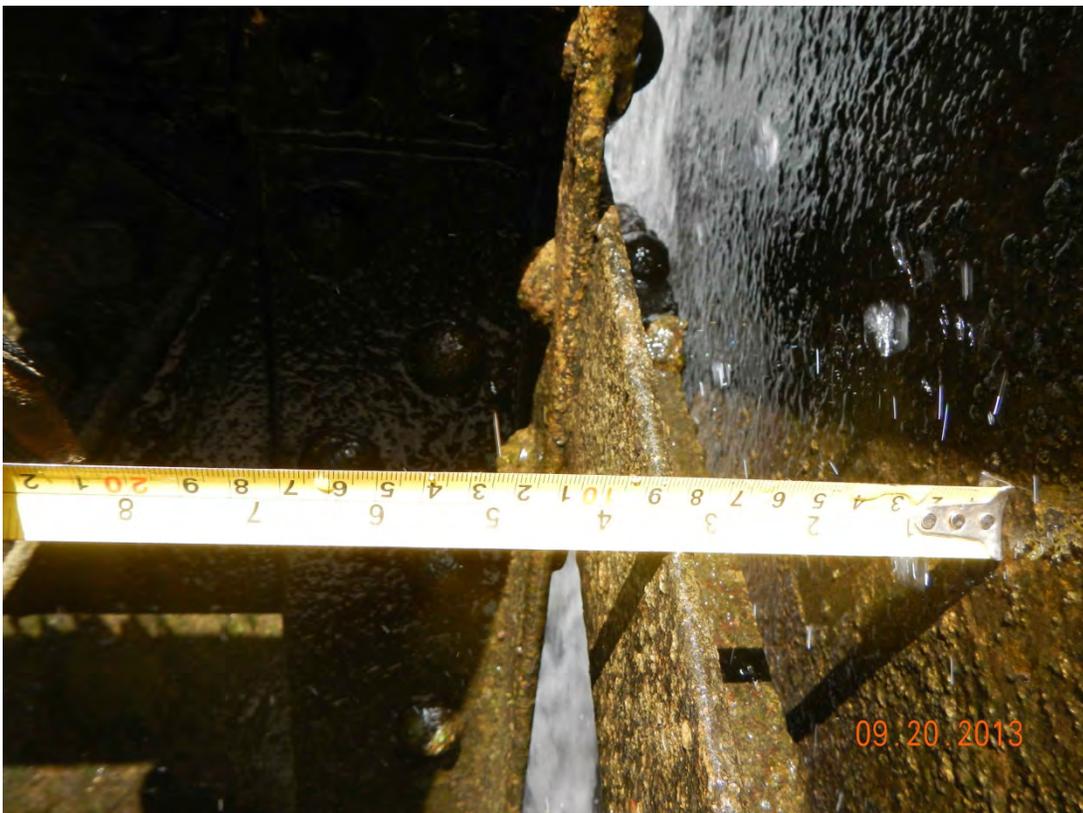
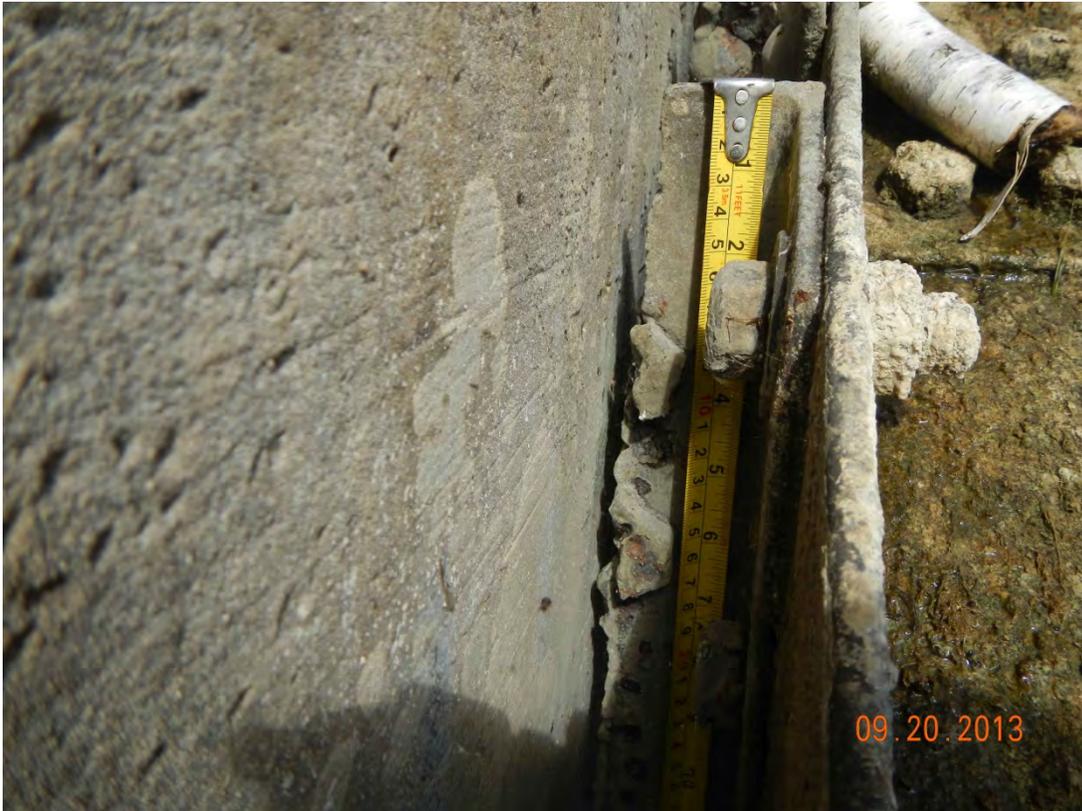
Photo 26: Gate 3 – right arm member cut for clearance to wall

Photo 27: Gate 3 – right arm member cut for clearance to wall

Photo 28: Gate 3 – right arm member cut for clearance to wall

Photo 29: Gate 3 – right arm member cut for clearance to wall

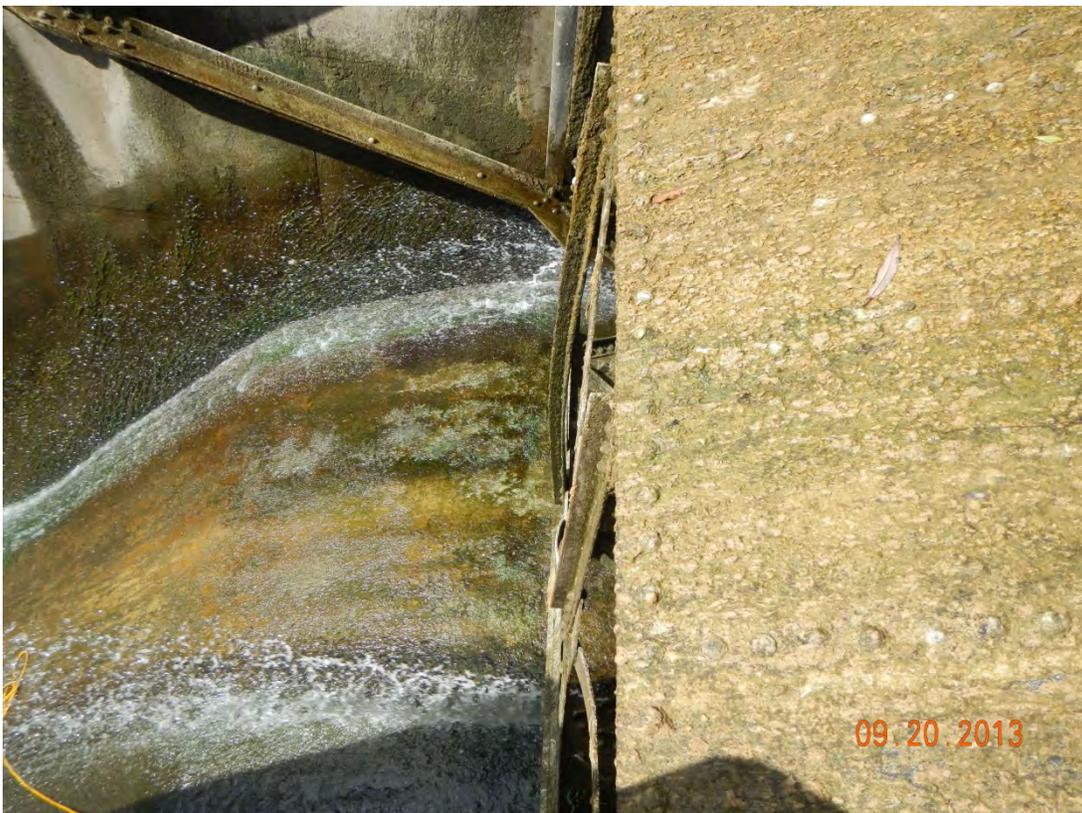
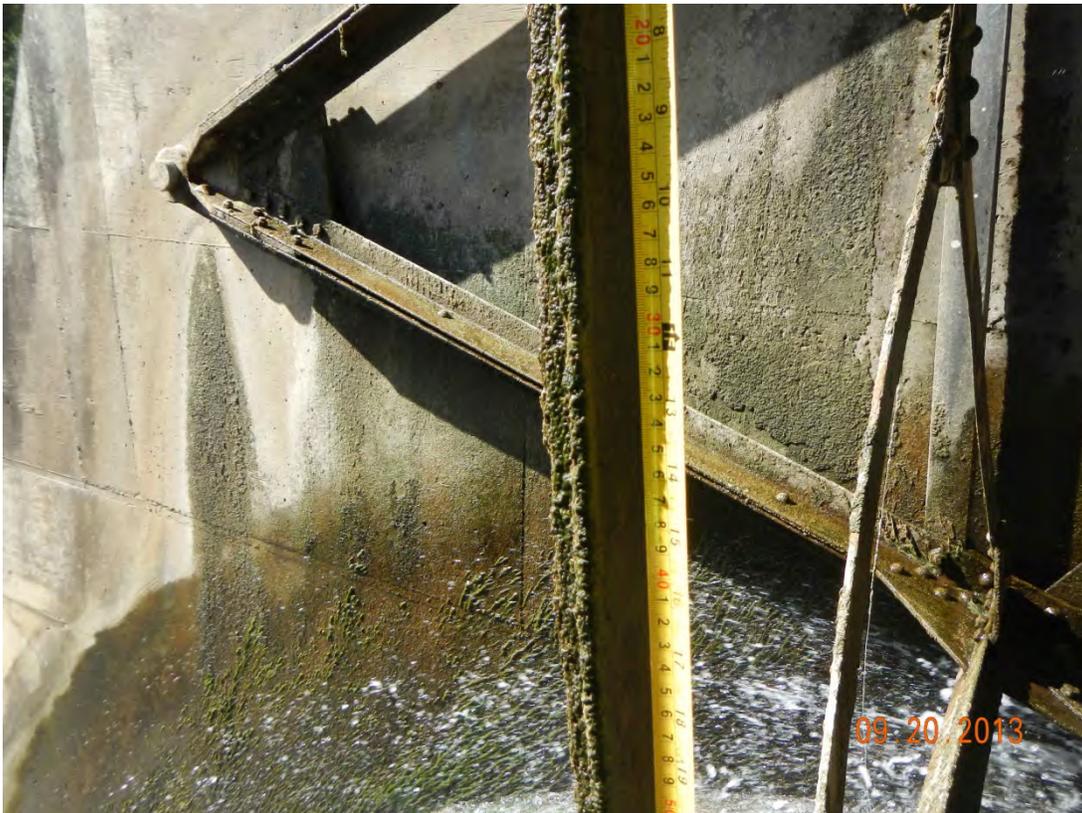
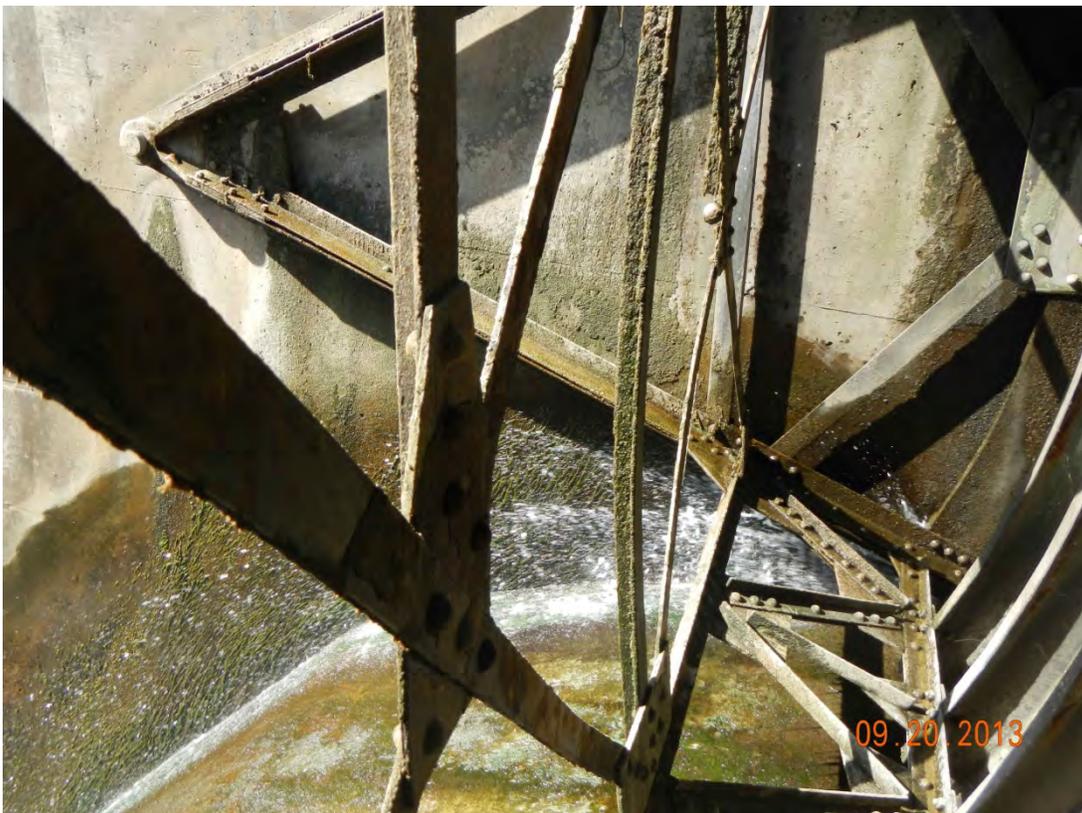
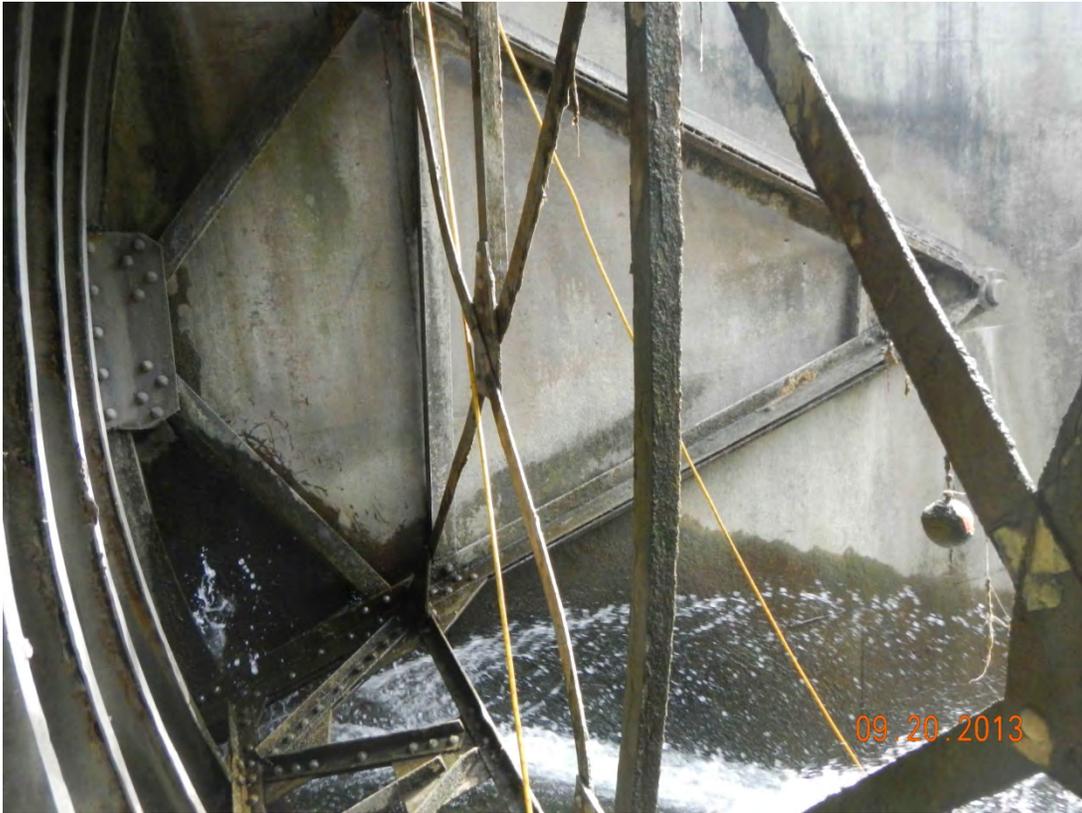
The bracing between the arms at the downstream side of the gate is bent.

Photo 30: Gate 3 – bent bracing

Photo 31: Gate 3 – bent brace

Photo 32: Gate 3 – bent bracing

Photo 33: Gate 3 – bent bracing
